LESSONS FROM THE FIELD - EJECTOR SYSTEMS

James R. Lines, Graham Corporation, USA, presents the problems associated with ejector system performance and subsequent solutions.

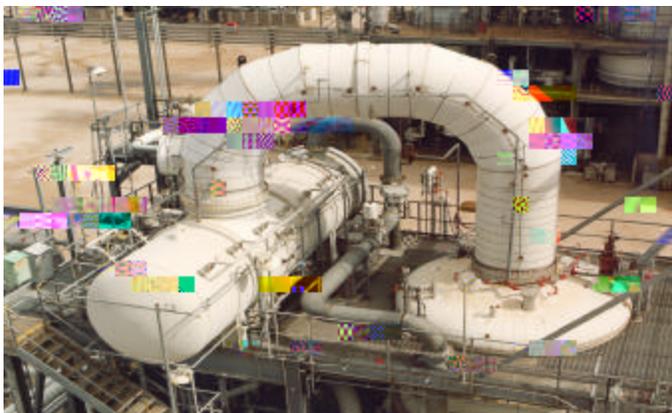
Figure 2. Precondenser to left of vacuum flasher

A North American petrochemical company manufacturing nylon intermediates was operating a vacuum flasher supported by a precondenser and two stage ejector system. Overhead load from the vacuum flasher consisted of 160 000 pph (72 600 kg/hr) of mixed nitriles at a pressure of approximately 35 torr.

The precondenser produced adequate vacuum, but the two stage ejector system that extracted non-condensibles from the precondenser was performing in an unstable manner. Suction pressure of the first stage ejector was cycling between the design 35 torr and up to as high as 75 - 80 torr.

Vacuum flasher pressure was unaffected by the ejector instability, however, plant personnel had concerns that poor ejector performance may at some point have a negative impact on vacuum flasher operating

pressure.

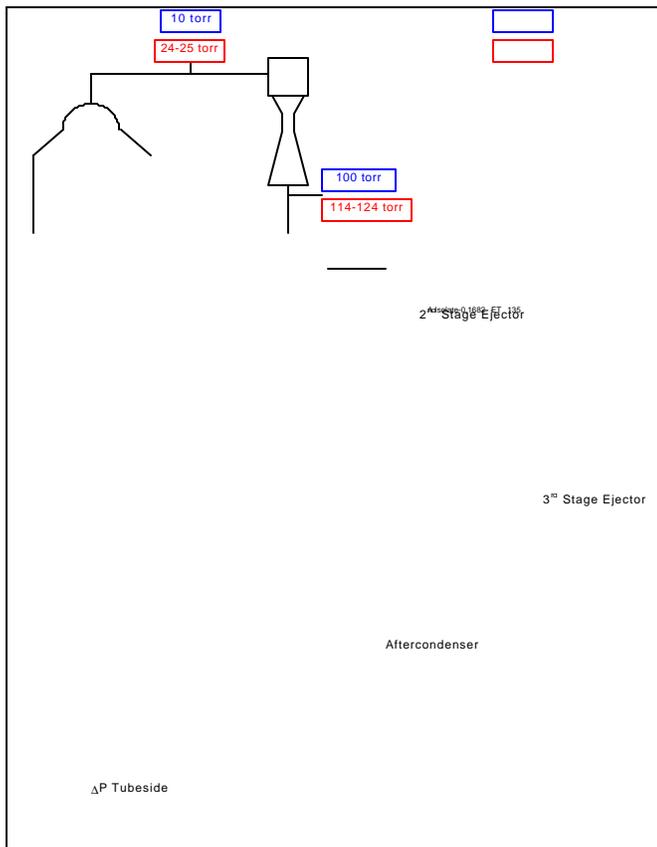
A Gulf Coast refiner was operating a damp crude vacuum distillation tower that was designed for 10 torr tower top pressure but was maintaining only 24 -25 torr. The first stage ejector was surging and back-streaming into the vacuum distillation unit. A factory service engineer was dispatched to the site to perform a system survey and evaluate causes of the poor performance.

Design cooling water temperature rise across the first intercondenser was 14 °F (7.8 °C), however, the actual temperature rise was 19 °F (10.6 °C). Possible causes for an elevated temperature rise would be lower than designed cooling water flow or an increase in condensible load to the condenser. Pressure drop across the tubeside of the condenser gave an indication that something was wrong. The actual tubeside pressure drop was 25 psi (1.7 bar) while the design was only 5 psi (0.35 bar).

The tubeside of the condenser was fouled and the increased pressure drop across the condenser caused the recirculating pumps to circulate less water. Tubeside fouling to produce such an elevated pressure drop would be severe and actual tube blockage must have occurred.

Tubeside fouling deterred heat transfer and did not permit proper condensation of shell side vapors. This increased the pressure drop on the shell side of the condenser and elevated its operating pressure. By not permitting proper condensation of shellside vapors, the increased outlet flow of vapors caused an increase in pressure drop.

The first stage ejector could not overcome the elevated shell side pressure drop and, consequently, broke operation. The broken operation resulted in unstable suction pressure, surging and back-streaming of motive steam into the vacuum distillation unit. The first intercondenser was pulled from the platform and taken down to grade. At grade, the bundle was removed to inspect the shell side for fouling and to rod out the tubes. The shell side did not experience excessive fouling, but the tubeside had tubes blocked with solidified calcium carbonate and other inverse solubility salts.

Once the tubeside was cleaned and returned to acceptable condition, the bundle was reinstalled in the condenser, and the condenser taken up to the vacuum unit for re-hook up. When the system was brought in service, the tower top pressure was maintained at approximately 10 torr and system performance was stable.
